EVALUATION OF PROTECTIVE GLAZING SYSTEMS

H. RÖMICH¹

1. Fraunhofer-Institut für
Silicatforschung, Bronnbach
28, D-97877 Wertheim,
Germany

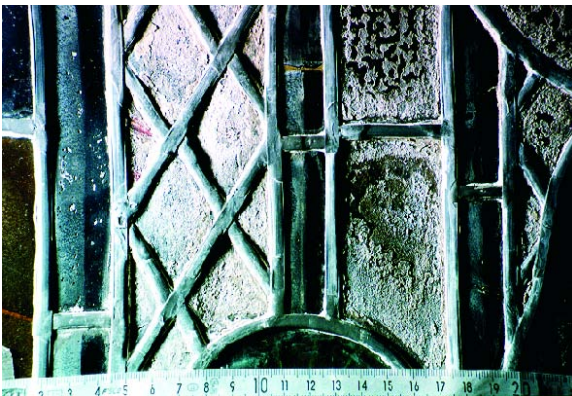
Figure 2: Detail of a stained glass panel from the Dome in Altenberg, Germany; the density of the corrosion crust depends on the composition of the glass and thus varies with in one panel (photograph provided by the Dombauhütte Köln, Germany)

Medieval glass, containing a rather high percentage of potassium and calcium, has developed a variety of corrosion phenomena over the centuries¹. The degree of decay varies from one window to the next, depending on the local conditions the glass was exposed to and depending on the restoration techniques applied during the window's history. The weathering of glass may lead to phenomena such as pitting or to the development of a dense crust of corrosion products (see Figure 2). For more stable glass from the 19th century, the loss of paint represents the major degradation phenomenon, mainly caused by condensation (Figure 3).

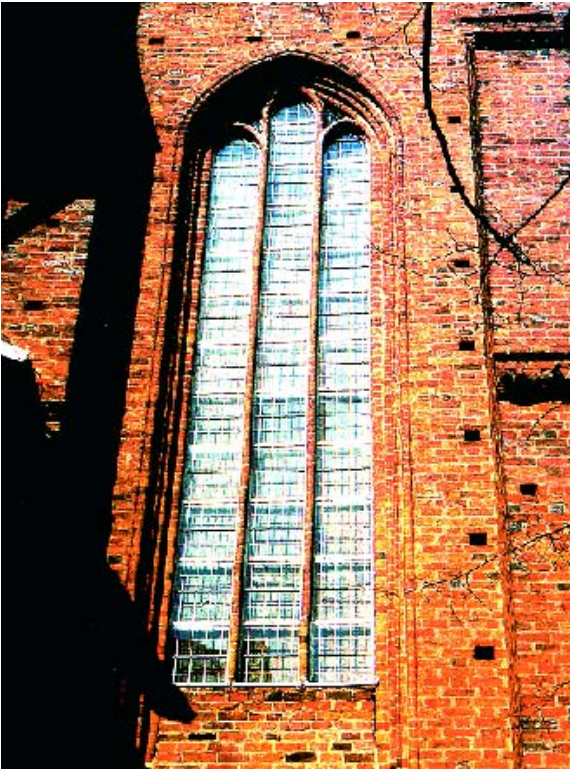
Figure 4: Protective glazing in Stendal, Germany⁸.

with anti-reflective coatings, clear leaded lights copying the original etc.) (see Figure 4). The distance of the stained glass to the protective glass and the size of the ventilation slots (top and bottom, but sealed on the verticals) has to be adapted to minimise condensation effects⁹.

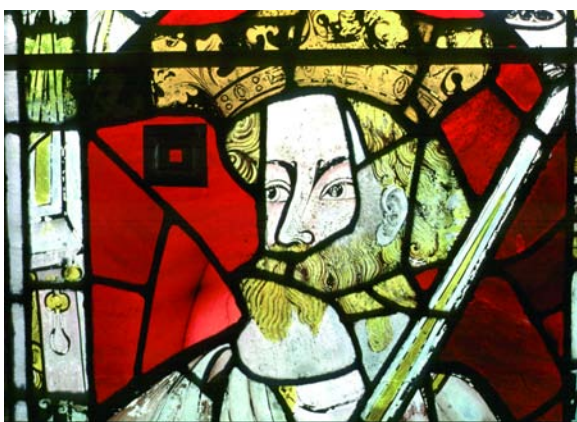
Figure 6: Installation of glass sensors in Gloucester (photograph provided by S. Strobl)

The glass sensor study was carried out at the Great East Window of Gloucester Cathedral from July 2000 to July 2001¹⁴. Figure 6 illustrates the installation of the sensors in Gloucester. A total number of 11 sensors were available for expo-

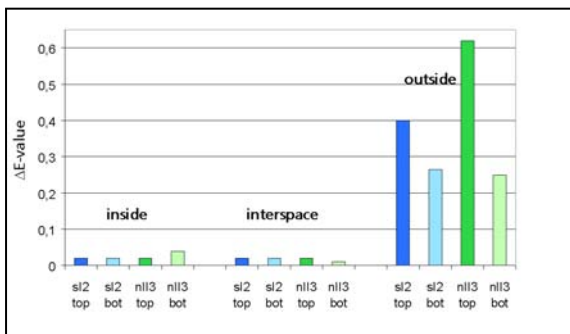
Figure 8: Glass sensor study in León (Spain): sensor positions (different windows, top and bottom) and corresponding stress levels detected on glass sensors (ΔE -values) for protected windows

From the results (shown in Figures 8 and 9) the following conclusions can be drawn for this study:

- for windows with a protective glazing the residual stress in the interspace is much lower than the potential for damage outside the building; this proves that the system applied in León (internally ventilated, slots at the top and the bottom) is appropriate for the objects and the environmental conditions in León
- for windows with protection there are no significant differences in stress level for the inside of the window and the interspace
- the environmental situation outside the building is characterised by very high corrosion rates on glass sensors (even higher in upper positions)
- the stress levels inside the cathedral are very low, for windows with and without protection.

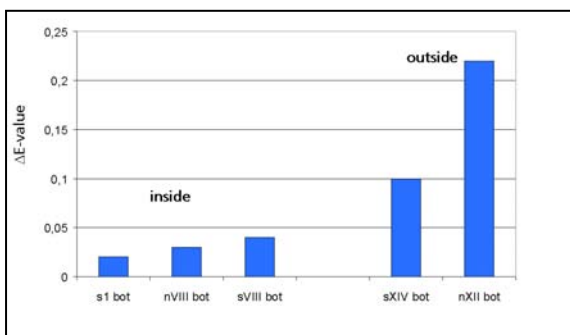
Figure 9: Glass sensor study in León (Spain): sensor positions (different windows, only bottom position) and corresponding stress levels detected on glass sensors (ΔE -values) for unprotected windows
