EXPERIMENTAL AND COMPUTER SIMULATION APPROACH TO INVESTIGATING THE ENVIRONMENTAL PERFORMANCE OF A RARE BOOKS ARCHIVE

FULL PAPER

This paper presents the findings of a pilot case study on the environmental performance of a rare books library situated on the campus of a major research university in the Midwest region of the United States

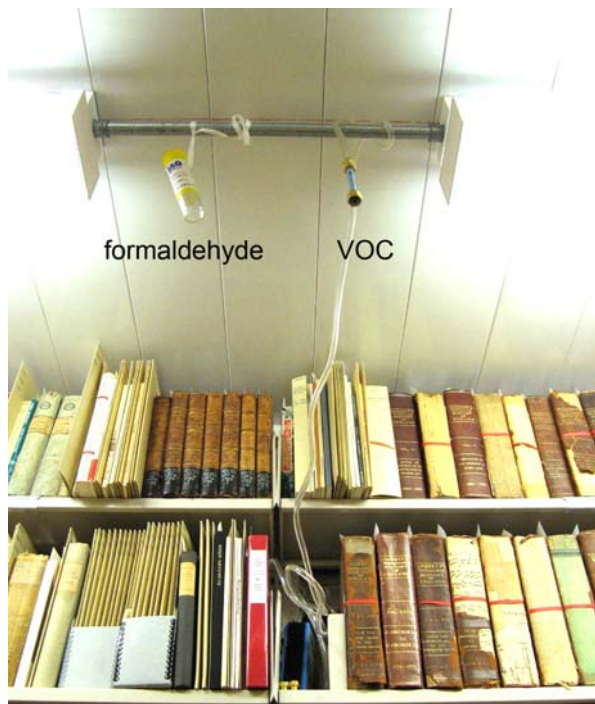
Figure 2: Formaldehyde and VOC samplers hung from light fixture.

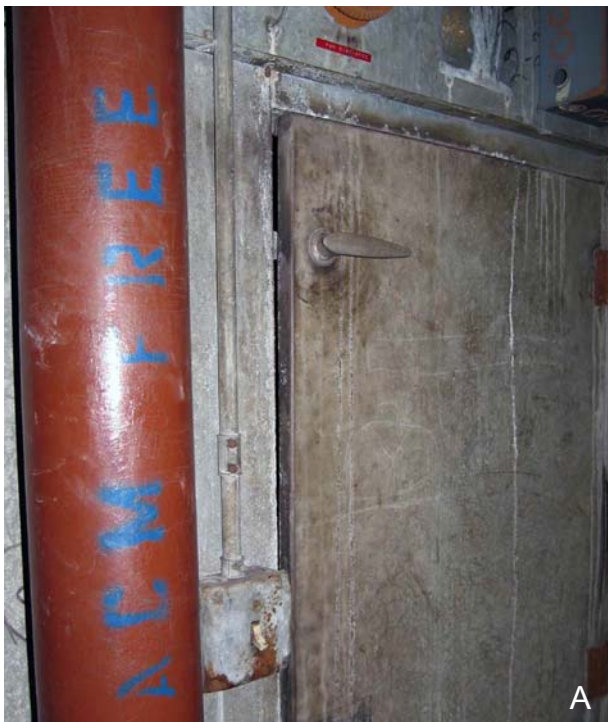
Figure 5: Images of air handling unit showing (A) bent access door with missing seals and (B) cooling coils with missing seals replaced with cotton rags.

Visual inspection of the building showed great deal of neglect and lack of understanding of how important it is to maintain strict environmental performance guidelines for archives. Figure 5 shows the effects of neglect and poor maintenance of the mechanical system. Figure 5A shows the access door of the one and only air handling unit (AHU)

bent with missing seals. The opening at the upper left hand corner of the door causes cold conditioned air to leak into the mechanical room causing condensation to occur around the equipment. Figure 5B shows the cooling coils of the AHU with missing seals. Instead of properly resealing the points of penetration, cotton rags are used to fill the gaps. This also causes a good deal of condensation and corrosion on the equipment as shown by the rust in the image. The wet cotton rags are also a potential source of mold growth. The condensation in the mechanical room is a possible contributor to the high fluctuation in relative humidity.

one of the causes for having only an 80% filtration rate. The archive staff were unaware nor had any input on how often or what type of filters were replaced. While the existing filters could be replaced with high performance filters such as high efficiency particulate air (HEPA) filters, it should be checked with a mechanical engineer to make sure it will not cause a drop in pressure within the HVAC system. However the standard filters could be replaced with fiberglass/potassium permanganate filters or pleated filters as a simple but temporary solution⁶.

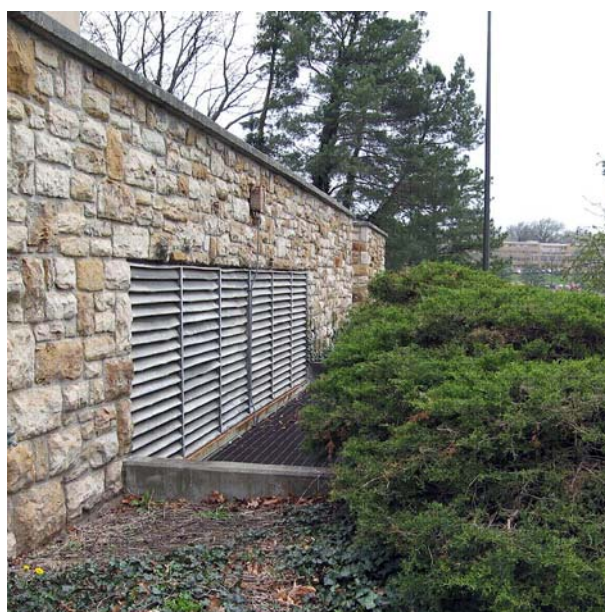
Figure 6: Image showing fresh air intake grill located very near vegetation and damp soil.

Figure 6 below shows the location of the fresh outdoor air intake grill. It is situated very near ground cover vegetation on the north side. Because of its orientation and the building to the south, the surrounding area is always in shade and the ground damp a good portion of the year. Combined with the poor performing air filters, this is a possible source of the soil based spores found in the stacks.
