TECHNICAL PAPER

PAINT INVESTIGATION OF ALTAR AND PULPIT IN THE CHURCH OF ST. MARY, VIGALA, ESTONIA

Signe Vahur^{*1,2}, Kriste Sibul², Pia Ehasalu², Väino Sammelselg³,
Ivo Leito¹

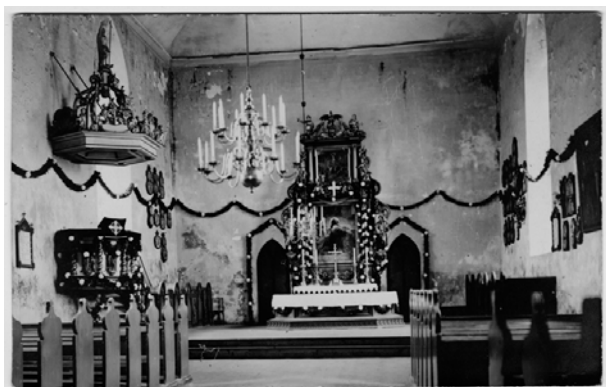
Figure 1. Inside view of the Vigala church in the 1920s (glass plate negative). Image from the photo collection of the art history department of the University of Tartu, Estonia.

The third colour layer of the altar is the result of an over-painting that was done using the brown-yellow-golden colour scheme (Figures 1, 2). The brown colour (Table 1 (sample no 1), Tables S1, S3)) consists of umber and fillers (chalk and probably barium carbonate). The golden colour (Table 1 (samples no 5, 6), Tables S1, S3) has two sub-layers: beneath the actual gold layer there is a preparative yellow layer, which according to the

The historical investigation and photos (Figures 1, 2) show that in 1888 the altar was gilded and silvered and that it had a brown-yellow-golden colour scheme before the most recent over-painting in 2005 (Figure 3).² The black and white photo (Figure 1) from the 1920s shows the altar already in the pre-2005 overpaint condition, which is also documented in the latest photos – dark corpus, brown oil-colour painting, gilt ornaments, angels and pillars (Figure 2). Based on this, the third layer (yellow-golden-brown colour scheme) was most probably applied in the course of the repainting in 1888.

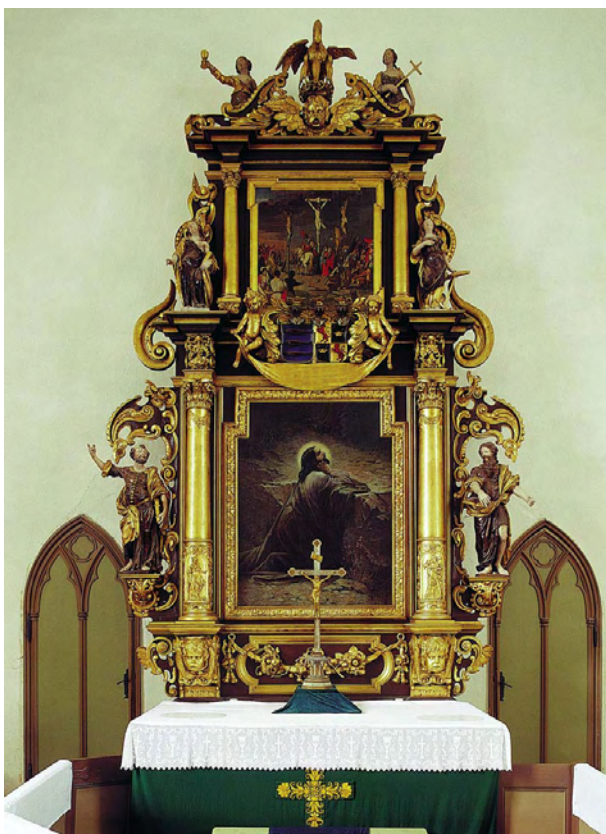
Figure 2. The altar before the over-painting in 2005 (photo by Peeter Säre).

The fourth layer analysis indicated that, before the most recent over-paintings in 2005, the corpus of the altar had three and the corpus of the pulpit four paint layers. Figures 2 and 7 show the altar and the pulpit before the over-paintings, figures 3, 8 and 9 display them after the over-paintings in 2005.

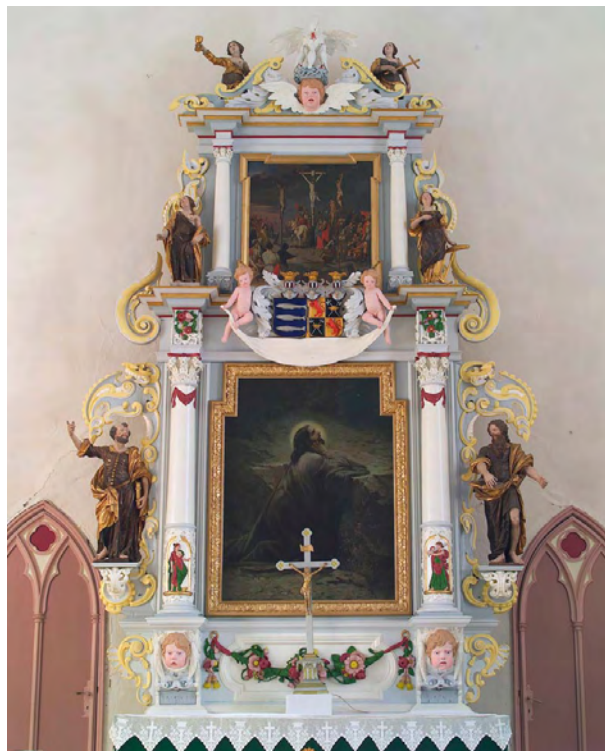
Figure 3. The altar after the over-painting in 2005 (photo by Jaanus Heinla, Conservation Centre "Kanut", Tallinn, Estonia).

2005	Over-painting of the altar and pulpit with oil- and alkyd paints. No over-painting of the sculptures.	The present colour scheme is shown in Figures 3, 8 and 9.

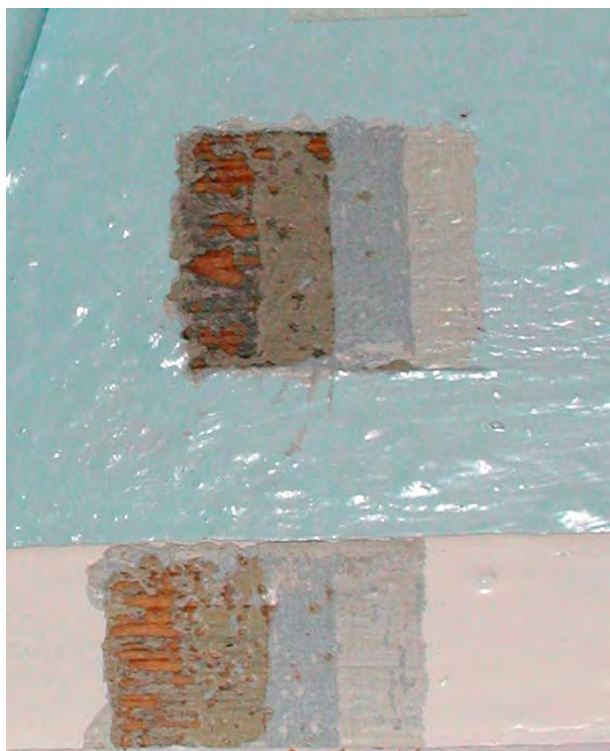
Figure 4. Windows made on sounding-board roofs side slats (Photo by Jaanus Heinla, Conservation Centre "Kanut", Tallinn, Estonia).

The light blue layer (Table 2; Fig 4) consists of white base and a blue pigment. SEM-EDS and ATR-FT-IR (see Fig S7) data indicated that the layers contain large amounts of lead white, calcium carbonate, barium sulphate and silicates. The binders are most probably some protein and oil. It was difficult with either SEM-EDS or ATR-FT-IR to identify the blue pigment because of its low concentration in that paint layer, as evidenced by optical microscopy, revealing only few blue pigment particles in the matrix of white colour. The SEM-EDS analysis of these particles indicated that it can be a silicate pigment. It is possible to exclude silicate pigments such as smalt¹⁰ and Egyptian blue,¹⁰ because cobalt and copper peaks were absent in the EDS spectra, respectively. Alternatively, the EDS spectra contained the peaks of all the elements of ultramarine ($3Na_2O \cdot 3Al_2O_3 \cdot 6SiO_2 \cdot 2Na_2S$).

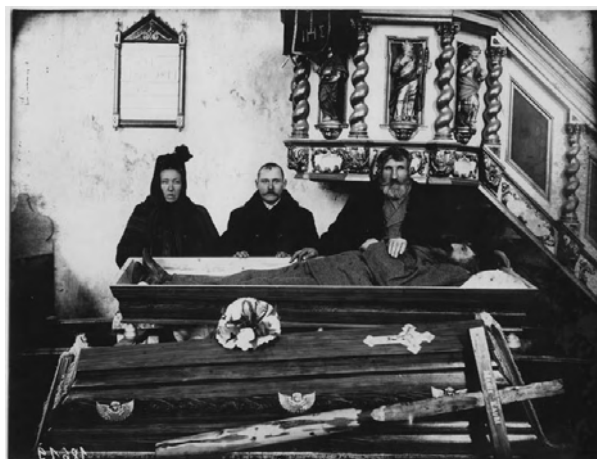
Figure 5. The pulpit at the beginning of the 20th century (photo by H. Reimer). Image from the photo collection of the Estonian History Museum (Tallinn, Estonia).

In the third layer some areas of the pulpit were painted using a brown colour. The side panels of the balustrade of the pulpit staircase were dark in the beginning of the 20th century according to Figure 4. The respective paint layer (Table 2, sample no 5) is brown. SEM-EDS analysis of the sample indicated that the brown pigment is brown

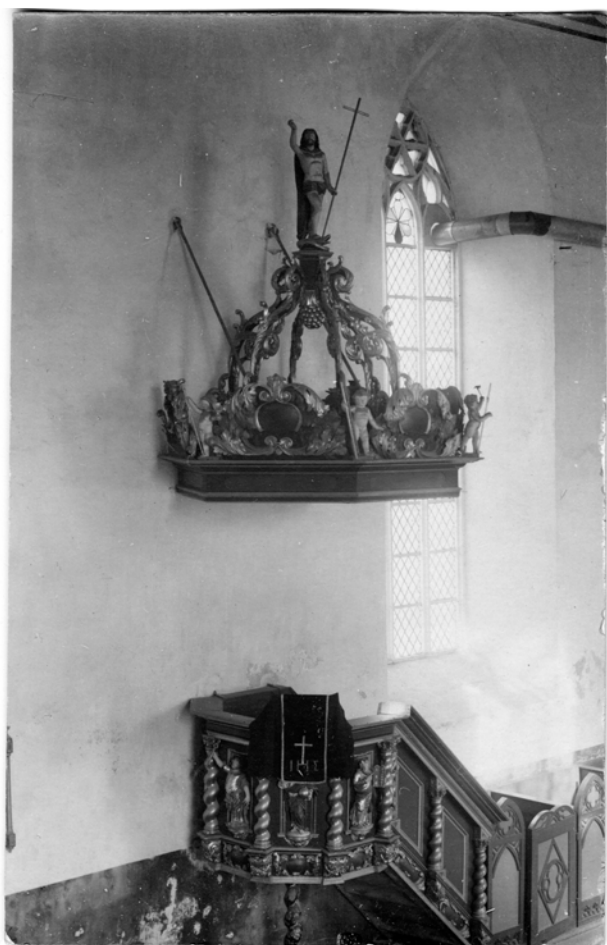
Figure 6. The pulpit after 1934. Image from the photo collection of the art history department of the University of Tartu, Estonia

According to the cross-sections and windows, the next extensive over-painting of the pulpit was performed in a darker brown colour tone, probably to match with the colour scheme of the altar. Only the pulpit was over-painted. The brown layer applied at that time consists of brown ochre and some fillers (Table 2, sample no 3). Historical investigations indicated that in 1927 repair works were planned in the church, but in archival documents there is no information whether the pulpit was involved in the repair works². Comparing the Figures 1 and 5 with the photo made in 1934 (Figure 6) it is possible to conclude that the pulpit and sounding-board have undergone over-painting during 1920-1934, the year 1927 falling within this time frame.

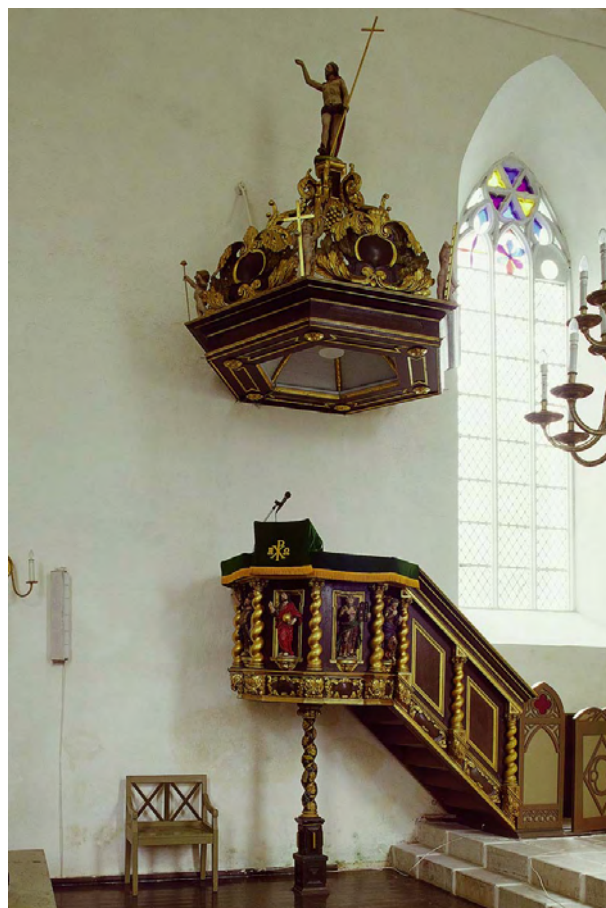
Figure 7. The pulpit before the over-paintings in 2005 (photo by Peeter Säre).

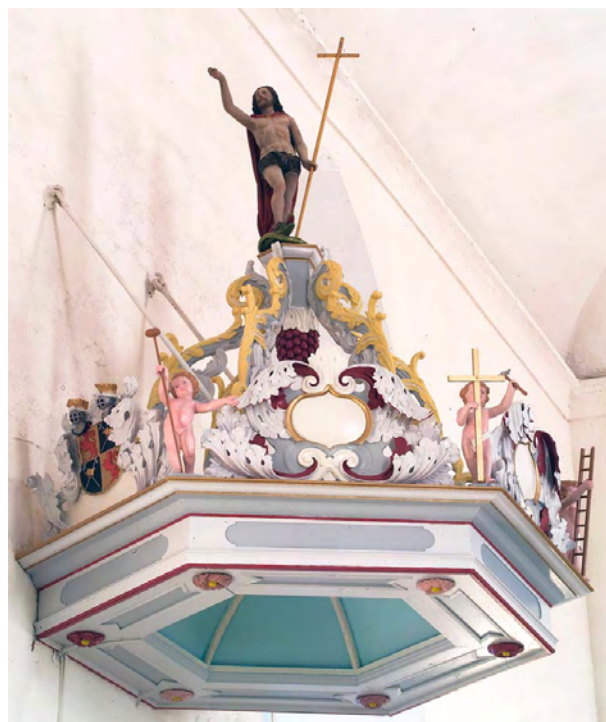
Figure 8. The sounding-board of the pulpit after the over-paintings in 2005 (photo by Jaanus Heinla, Conservation Centre "Kanut", Tallinn, Estonia).

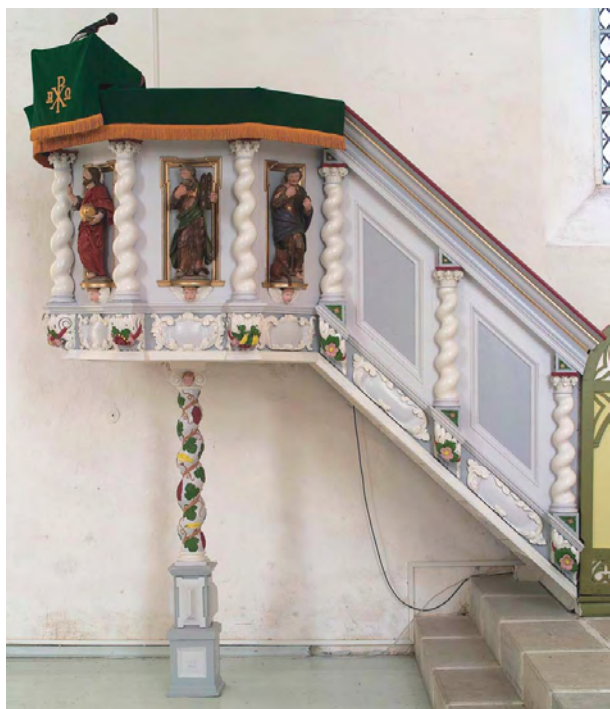
Figure 9. The pulpit after the over-paintings in 2005 (Photo by Jaanus Heinla, Conservation Centre "Kanut", Tallinn, Estonia).
