SCIENTIFIC PAPER

SENSOR SYSTEM FOR DETECTION OF HARMFUL ENVIRONMENTS FOR PIPE ORGANS (SENSORGAN)

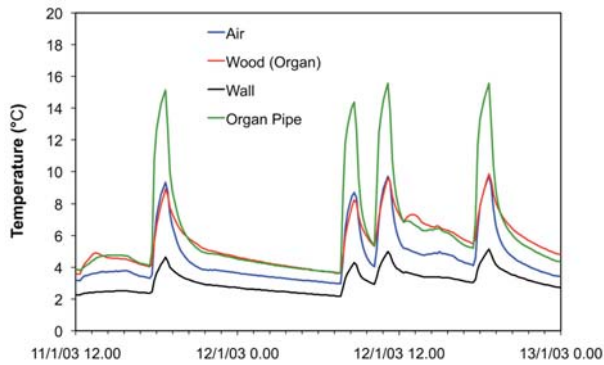
Figure 1: Temperature of the air, wall, wooden part of the organ and organ pipe measured at 5.5 m above the floor. Peaks correspond to warm-air heating at services.

parts of the organ, making the instrument unplayable. The organ facade, often containing invaluable art handicraft like wood carvings and sculptures, can also be damaged by such an environment. Each part of the organ responds in a different way when the church is heated or cooled. The parts with high thermal diffusivity (TD), i.e. the ratio between thermal conductivity to volumetric heat capacity, rapidly adjust their temperature to that of their surroundings, because they conduct heat quickly in comparison to their bulk thermal energy. For this reason the metal pipes closely follow the air temperature, the wooden parts with some delay, and the masonry all around does this very slowly (Figure 1).

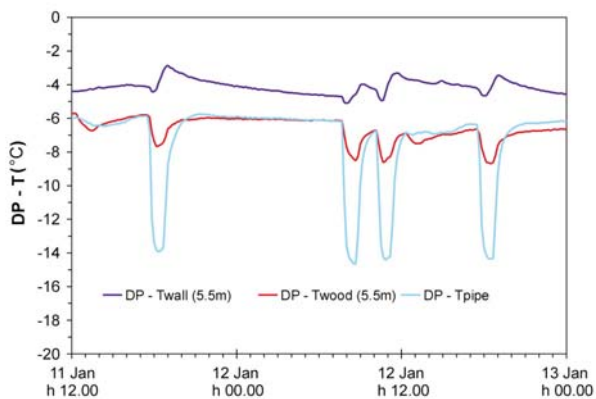
Figure 2: Dew Point (DP) spread of the wall, the wooden part of the organ and the organ pipe (all, 5.5 m). Peaks and drops correspond to warm-air heating at services.

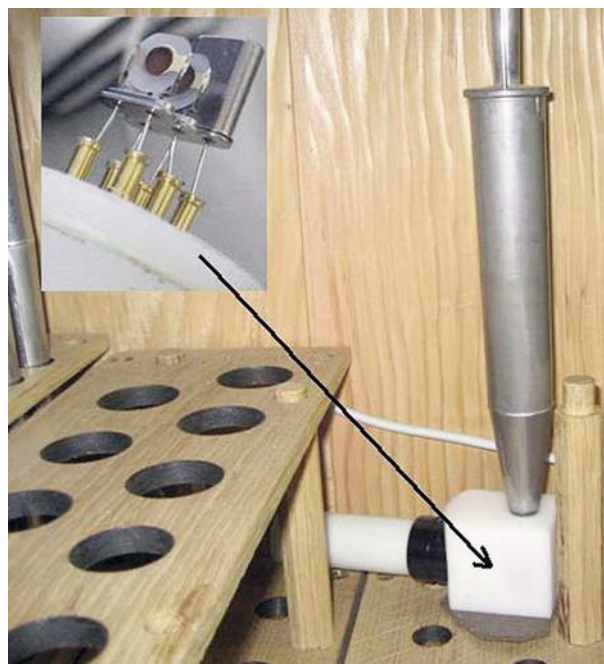
Figure 6a: View of crystal holder located at toe of pipe raised from the toeboard in the organ in St. Botolph. Top left gives view of crystals in holder.

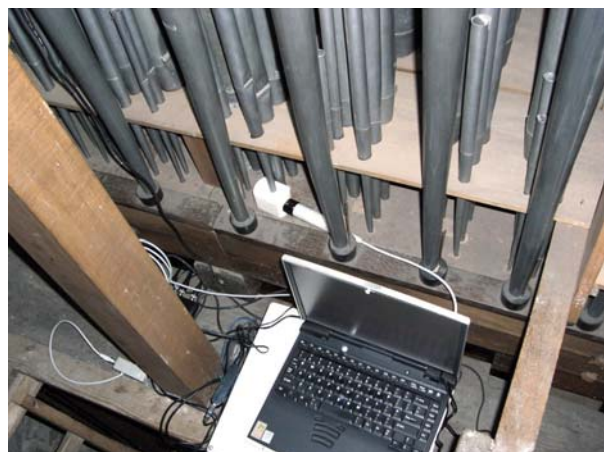
Figure 6b: System in operation in the Minor Basilica of St. Andrew the Apostle, Olkusz.

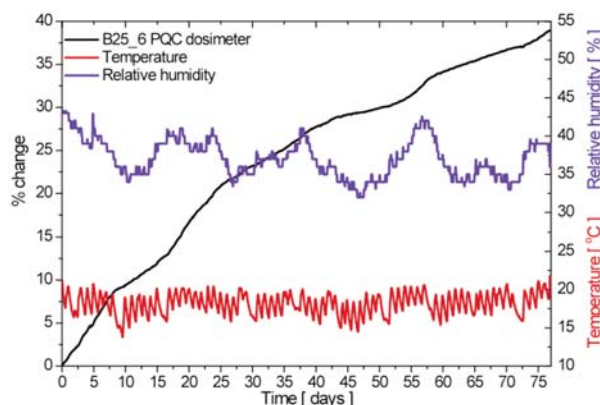
Figure 7: Record of % change in crystal frequency values recorded at St Botolph plotted against time (days) together with climate data (RH,T), location Figure 5 (A).

Figure 7 shows the data obtained from continuous monitoring (location Figure 5 A) using the newly developed small holder and miniaturized electronic components over a period of one month of a selected organ pipe in St Botolph.

Level after 15 days (Figure 7) was lower than in the windchest (Table 1 1st exposure 28.11.06 - 14.12.06, location Figure 5 B) and similar to that measured in an array placed in the vicinity of the pipe (Table 5, location Figure 5 C). So corrosivity due to acetic acid is stronger in the windchest (location B) where change % after 16 days is up to 17% than in the organ pipes where it is about 12.5%. The environment within and outside the pipe gives similar values for change (%) in the lead coated crystals.

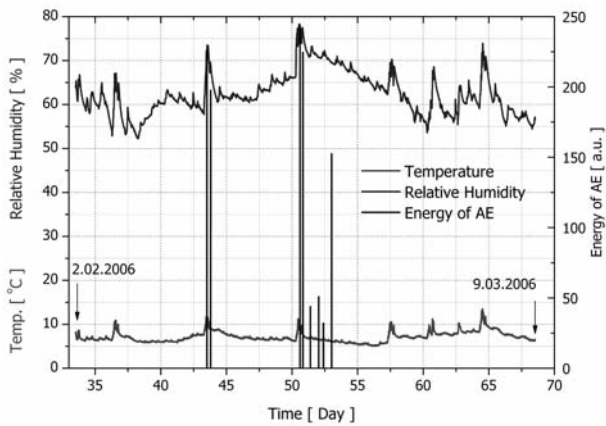
Figure 8: Acoustic emission recorded in the reference organ during the winter period.

Only a few AE episodes of small energy generated due to fluctuation in relative humidity during services were recorded indicating that wooden parts of the organ are at limited risk caused by the microclimate in the church as shown in Figure 8.

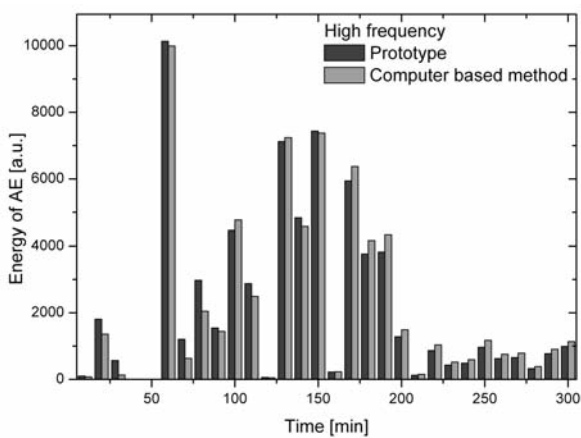
Figure 9: Energy of AE generated in lime wood sample during test in climatic chamber. RH change 70 to 30%.

Comparison of results obtained during the field campaign showed that efficiency in recording AE events by the developed sensor associated with wood cracking was ca. 90% of the value recorded by professional equipment. Similar value was obtained during laboratory tests in a climatic chamber when a wooden cylinder of diameter 13 cm was subjected to RH variation. Results of the test are shown in Figure 9.

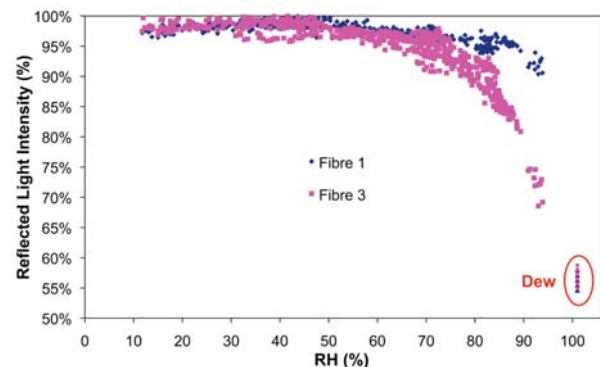
Figure 10: Normalised response of two optic fibres (blue and purple points) to relative humidity and condensation. The output shows a plateau for RH lower than 80%. At higher values the output starts to decrease. When liquid water forms, the output drops to 50-55% of the plateau level (points in the red circle).

When liquid water (Figure 10), or ice crystals form (Figure 11), the output drops to 50-55% of the plateau value for liquid water and less for ice. The latter is however recognizable for the combination with temperature below 0 °C. For this reason it is convenient to express the output as a fraction of the plateau value: it is 1 in the safe region, it starts to drop in the alert area where water starts to be absorbed at faster rate and is halved in the case of condensation or frost. The output expressed as a percentage of the plateau value has a further advantage: to be independent from contamination of smoke or dust particles eventually deposited on the sensing surface, which might affect the fraction of back light. Condensation and frost can be easily distinguished with the help of a temperature reading.

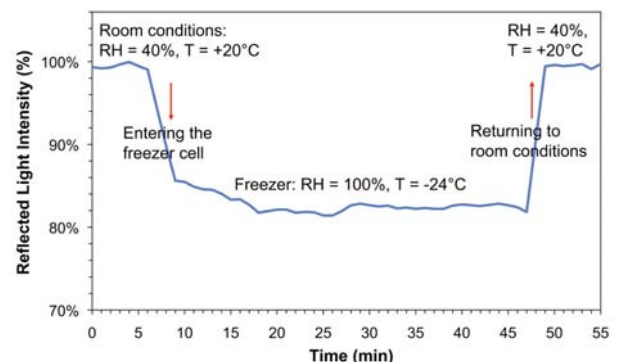
Figure 11: When the fibre is introduced into a freezing cell (T=-24 °C) the output drops for the formation of ice crystals. It returns to normal conditions when it is extracted from the cell at room temperature (T=+20 °C).

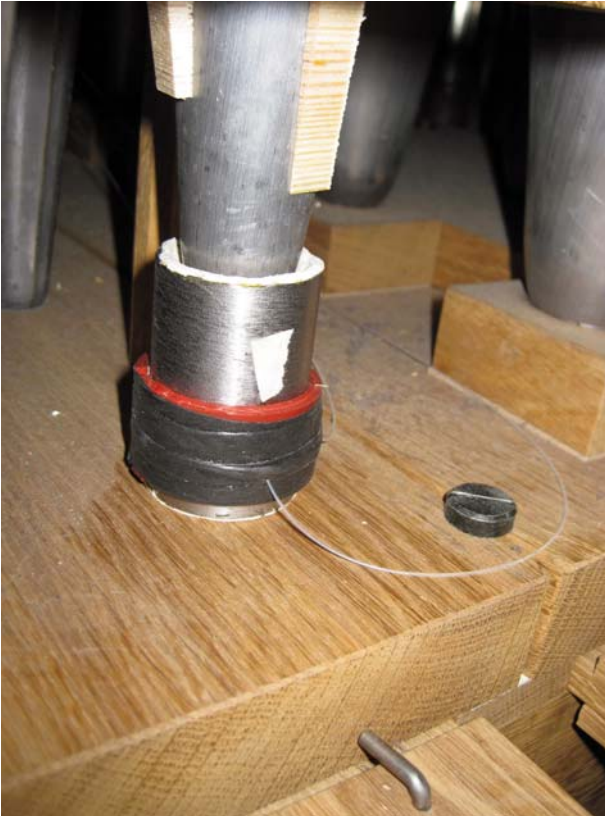
Figure 12: During the experiment, an adapter was inserted between the pipe foot and the toeboard hole in order to make easier the passage of the optical fibres and avoid any damage when handling the fibre or the pipe.

similar additional neck is preferable between the pipe foot and the toeboard hole (Figure 12) during the experiment. Alternatively a three leg spring (Figure 13), one leg per each fibre, can be inserted from the bottom and, once released it brings the three fibres (Figure 14) in the correct position and into physical contact with the internal surface of the pipe foot. This system is easy to mount, not dangerous for the pipe, holds the three fibres in contact with the internal pipe surface, and is easy to remove.

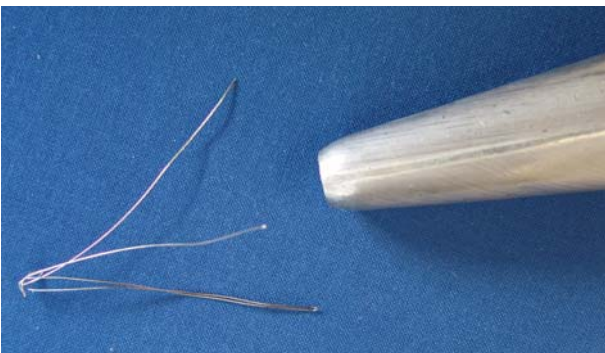
Figure 13: Detail of the spring in string steel with three arms to hold three optical fibres and be inserted into the hollow tip of the pipe foot although the hole is a few mm in diameter.
