## THE ROCK HEWN WALL PAINTINGS IN CAPPADOCIA (TURKEY).

### CHARACTERIZATION OF THE CONSTITUENT MATERIALS AND A CHRONOLOGICAL OVERVIEW

#### TECHNICAL PAPER

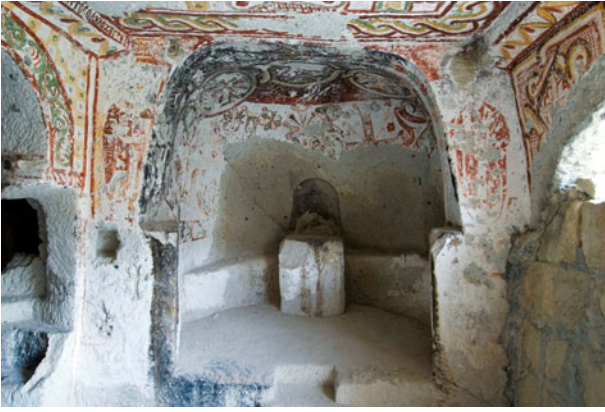
Figure 1: The rock hewn wall paintings of the Hagios Basilios Kilisesi at Mustafapaşa.

Within this group of churches, it was possible to sort out the paintings dating back to the 6<sup>th</sup> and 7<sup>th</sup> Centuries: Hagios Stefanos Kilisesi, Keşlik Monastir at Cemil; Hagios Basilios Kilisesi at Mustafapaşa (Fig. 1); Joachim ve Anna Kilisesi at Kizil Çukur; Üzümlü Kilisesi at Kizil Çukur; Karşibecak Kilise at Avcılar/Göreme, and the churches dating from the iconoclastic period (8<sup>th</sup> – 9<sup>th</sup> Century)<sup>6,13</sup>: Güllü Dere nr. 5 (Süslü Kilise) and Kapılı Vadısı Kilisesi at Karacöeren (Fig. 2), which are characterized by an exclusively aniconic decoration.

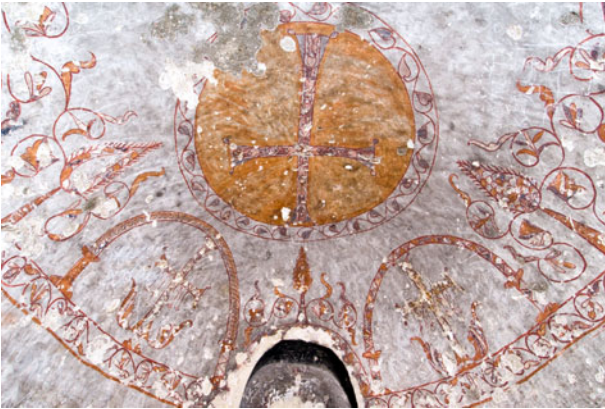
Figure 2: The rock hewn wall paintings of the Kapılı Vadısı Kilisesi at Karacöeren.

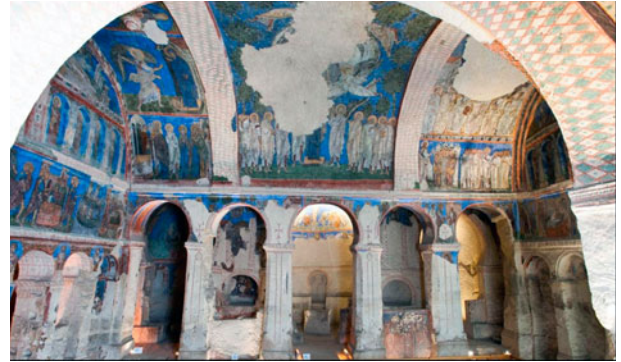
Figure 3: A partial view of the interior of the New Tokalı church with extraordinary wall paintings.

As an example of the pictorial evidence of the 10<sup>th</sup> Century in Cappadocia, the New Tokalı church was studied. This church is the most important monument of the Open Air Museum in Göreme (Fig. 3).<sup>14-16</sup> Since 2011, the first step forward the process concerning the analysis and restoration of the wall paintings has been taken, in collaboration with the Archaeological Museum of Nevşehir.

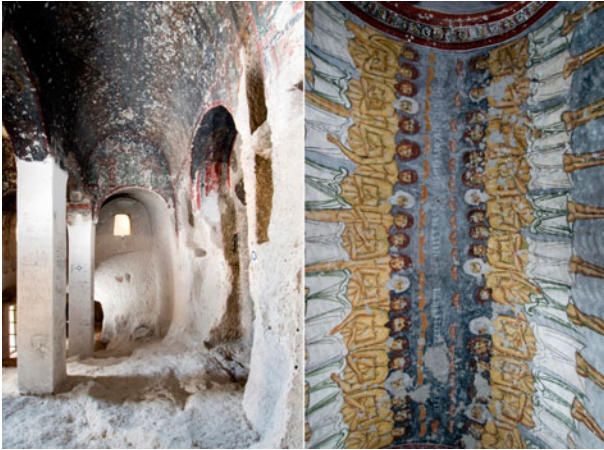
Figure 5: The Forty Martyrs' scene at Şahinefendi before and after the cleaning intervention.

The 13<sup>th</sup>-Century churches are characterized by wall paintings applied on pink-white mortars sometimes containing fibres. The plaster was generally spread by means of large horizontal bands relating to scaffolding lifts (*pontata*). In the Forty Martyrs' church, conservation work was performed in order to unveil the wall paintings covered by a thick sooty layer due to fires lit in the past. The cleaning intervention revealed a figurative cycle developed throughout the two naves of the church (Fig. 5).

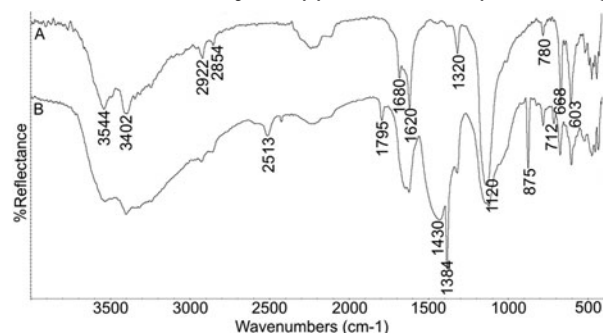
Figure 17: Diffuse reflectance FTIR spectrum of two samples from the church of Sarica nr.1. A is the spectrum of a sample from the first pictorial phase, B is the spectrum of a sample from the second pictorial phase.

The Sarica Kilise nr. 1 at Ürgüp is characterized by two very fragmentary pictorial phases: in the first one, showing aniconic paintings, gypsum with traces of organic compounds is used. The second phase (Fig. 15c, d) that may be dated back to the 13<sup>th</sup> century is characterized by a plaster made of calcium carbonate, gypsum and organic compounds with traces of calcium oxalate (Fig. 17).
